Manhole Inspection Summary

Manhole # **S17G__026MH**

Insp Date: **10/3/07 4:45 PM**

Location Address: **2555 CALVERTON**

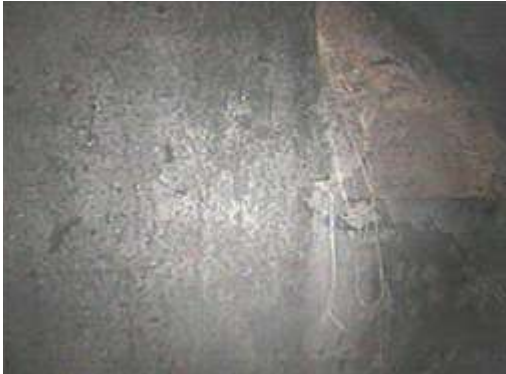
Defect 1

Condition: ☐ Sound ☐ Cracked ☒ **Root Intrusion** ☐ Loose Brick ☐ Deteriorated

Infiltration: ☐ None ☐ Joint ☐ Cracks ☐ Mortar ☒ **Roots** ☐ Wall

ROOT INFILTRATION FINE- BARREL

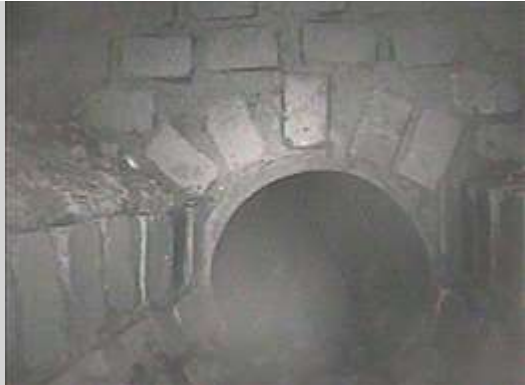
12 O'Clock Outflow

Pipe Height: **8.4** (in.) Rod and Bar
Pipe Material: **Clay** ☐ Pipe Lined
Invert Depth: **16.32** (ft.) Flow Characteristics: **Slow**
Deposits: ☒ None ☐ Mud ☐ Sludge ☐ Debris ☐ Grease
Silt Depth: (in.) Deposits Extent:
Infiltration: **None** Pipe Seal Cond: **Sound**

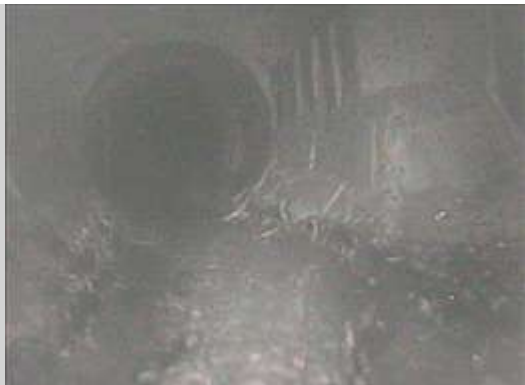
6 O'Clock Inflow

Pipe Height: **9.6** (in.) Rod and Bar
Pipe Material: **Clay** ☐ Pipe Lined
Invert Depth: **16.11** (ft.) Flow Characteristics: **Slow**
Deposits: ☒ None ☐ Mud ☐ Sludge ☐ Debris ☐ Grease
Silt Depth: (in.) Deposits Extent:
Infiltration: **None** Pipe Seal Cond: **Sound**

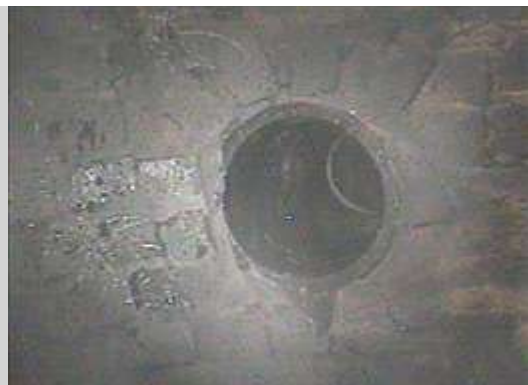
9 O'Clock Inflow

Infiltration: **None** Pipe Seal Cond: **Cracked**

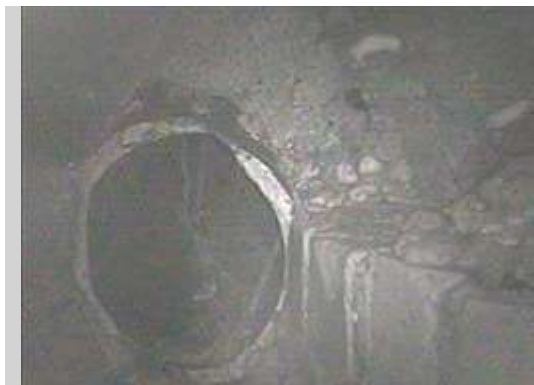
Drop In @ 9 O'Clock

Drop: **Outside Direct**

Drop Condition: **Open**
